# **Challenges in the Preservation of Disaster Remains** – Example of the Chelungpu Fault Preservation Park

Cheng-Shing Chiang<sup>\*1,†</sup>, Tyan-Ming Chu<sup>\*2</sup>, Wen-Hao Chou<sup>\*3</sup>, Shin-Ho Lee<sup>\*4</sup>, and Jer-Fu Wang<sup>\*5</sup>

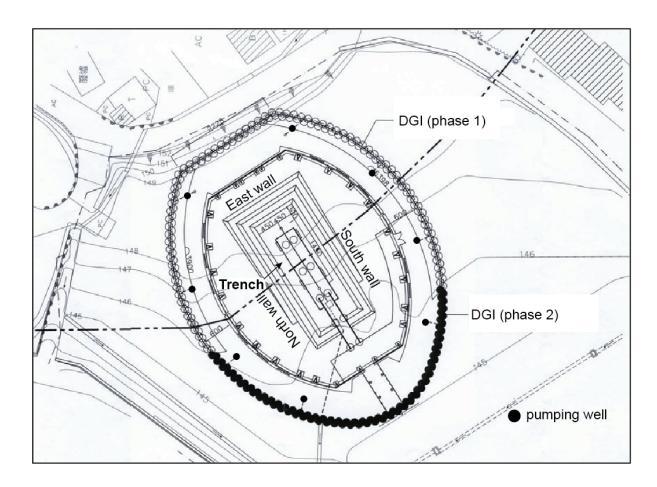
**Fig. 4.** DGI curtain and eight pumping wells outside the preservation dome.

The original Chushan trench was excavated in the SE-NW direction, 35-m in length, 14-m in width, and 8-m in depth [8]. After two re-excavations, the width of the trench increased to 17.5 m [10]. When the site was selected for an earthquake fault museum, protection of the trench was the main concern. A protective dome, an enclosed underground curtain produced via double grid injection (DGI) method at a depth of 11-14 m, and a 6 m wide concrete pavement covering of the space between the dome and the DGI curtain were designed and constructed. In addition, eight pumping wells were drilled 18 m deep to the underlying gravel aquifer outside the dome to lower the groundwater table (**Fig. 4**).

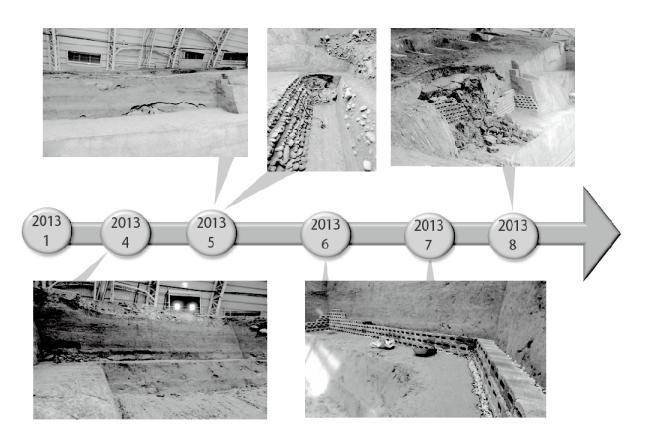
Fig. 5. The collapse history of the CFPP trench.

Following the construction of the dome and "waterproof" facilities, re-excavation work began in October 2012. It was divided into two stages. In the first stage, most of the sand bags used to backfill the trench were removed with a mini excavator. In the second stage, the surface of the trench was repaired and trimmed by an archeology team from NMNS. The excavation was conducted during the dry season. There were no significant issues with water and the work was finished successfully. The CFPP started its trial operation in early 2013, but the rainy season began in early April that year resulting in continuous seepage at the second-level in both the south and north profiles of the exhibition trench. At the end of August, the north profile collapsed. The collapse history of this trench is shown in **Fig. 5**.

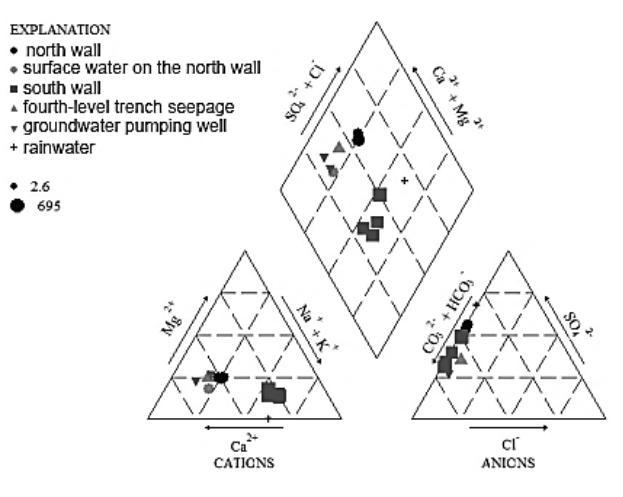
**Fig. 6.** Piper-Hill diagram of the water samples collected for seepage investigation.

Piper-Hill diagram was used to identify water sample chemical characteristics (Fig. 6). Fresh natural water was of Ca-HCO<sub>3</sub> type in the zone left to middle of the rhombus. The water type of south-wall seepage was (Na, K)-(HCO<sub>3</sub>, SO<sub>4</sub>), which was fairly different from that of other water samples. The water type of the northwall seepage was Ca-(SO<sub>4</sub>, HCO<sub>3</sub>). Although this was similar to the surrounding natural water, its sulfate concentration was significantly higher. Concentrations of Na and K were also slightly higher than in the ambient water samples. By reviewing the site conditions, the differences in water chemistry of the south-wall and north-wall seepages were due to chemical reactions with the underground DGI curtain. The degree of impact of DGI on water chemistry was more significant for south-wall seepage than for north-wall seepage.

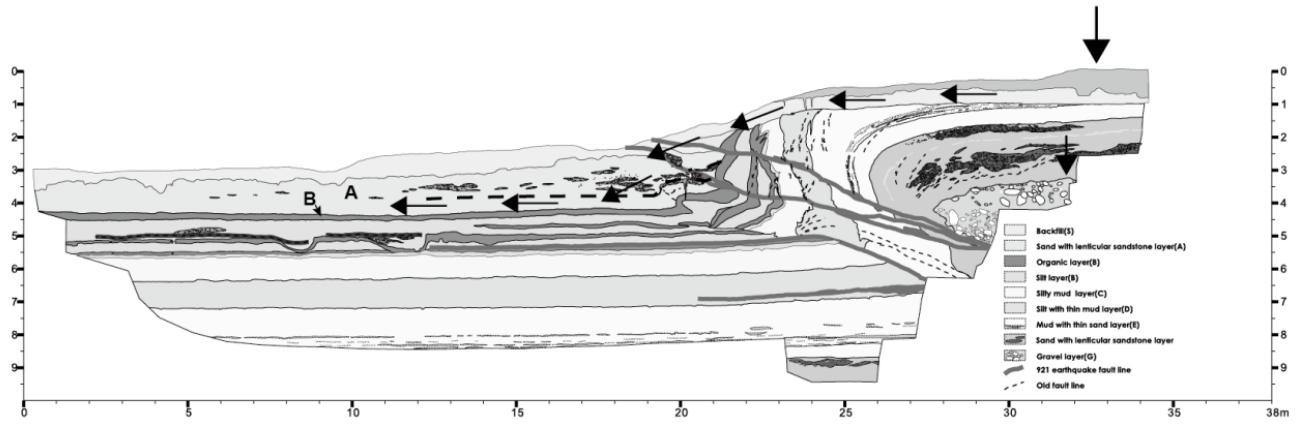
Fig. 7. Schematic diagram of the seepage path along the north wall of the trench.

A large amount of water flowed into the dome area from the east where there was lack of DGI curtain. However, most of the infiltration ran down into the gravel layer, then vertically into the aquifer below. A small portion was able to pass the fault zone and reach the footwall north of the trench. The saturated infiltration then flowed laterally along the bottom of layer A, which lies on top of the footwall with a higher permeability than the underlying layer B. Finally, the water seeped out at the boundary of A and B layers along the western part of the north wall (**Fig. 7**).

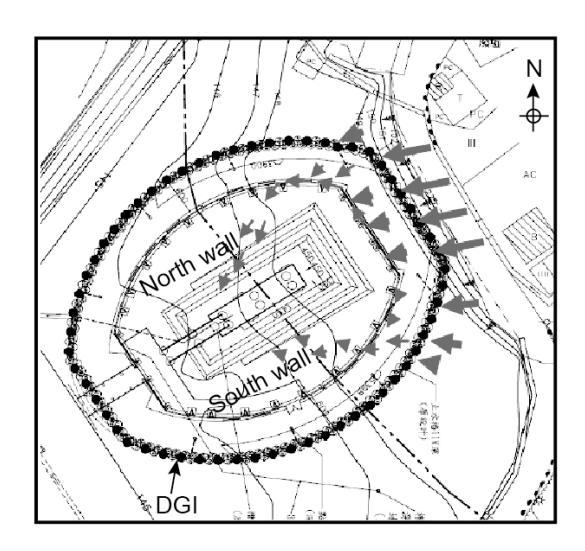
The results of this study explain why there was more seepage from the north wall than from the south wall. Combining the local hydrogeology and water chemistry data, it can be concluded that most of the south-wall seepage runs through the DGI curtain and most of the north-

Fig. 8. Schematic diagram of the seepage path in the CFPP.

wall seepage is from infiltration passing through the section with limited DGI curtain on the east side of the dome (**Fig. 8**).

Based on the results of the hydrogeological survey, a shallow steel sheet pile curtain outside the DGI was proposed for the eastern portion of the dome to stop shallow infiltration. A long-term monitoring network was also created. Monitored items include precipitation, soil moisture content, amount of seepage, and groundwater table.

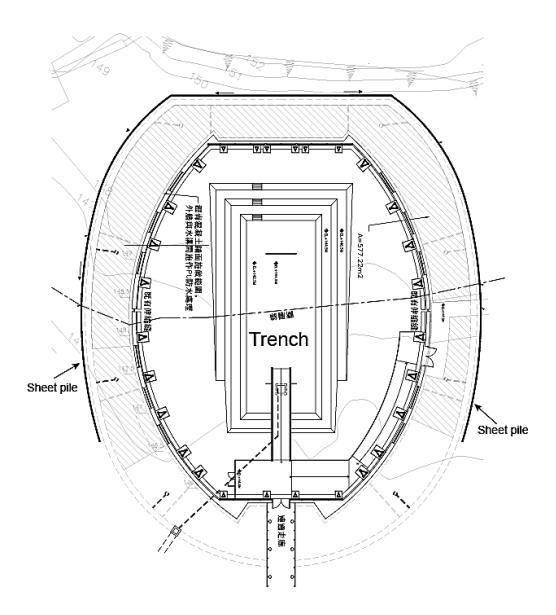
Fig. 13. Layout of sheet pile curtain.

To stop possible infiltration from surface runoff and lateral flow at shallow depth, two measures were implemented. The cracks along the edge of the concrete surface surrounding the dome were carefully sealed to prevent leakage from runoff. A 3-m long steel sheet pile was driven into the ground outside the DGI to stop lateral infiltration at shallow depth (**Fig. 13**). This steel curtain was not able to be installed along the shallow gravel layer.

After the completion of the steel curtain at the end of 2014, the seepage problem along the south wall of the trench was effectively resolved, but seepage along the north wall was not significantly reduced. The steel sheet pile to the northeast of the fault line was not deep enough, resulting in gaps for water to run through. Most of the seepage was along the bottom of layer A close to the fault zone (**Fig. 7**). A large-diameter well was placed inside the dome on top of the northern footwall near the fault zone to intercept the seepage. Finally, the seepage was controlled and the soil strata became stable.
