# **Challenges in the Preservation of Disaster Remains** – Example of the Chelungpu Fault Preservation Park

Cheng-Shing Chiang<sup>\*1,†</sup>, Tyan-Ming Chu<sup>\*2</sup>, Wen-Hao Chou<sup>\*3</sup>, Shin-Ho Lee<sup>\*4</sup>, and Jer-Fu Wang<sup>\*5</sup>

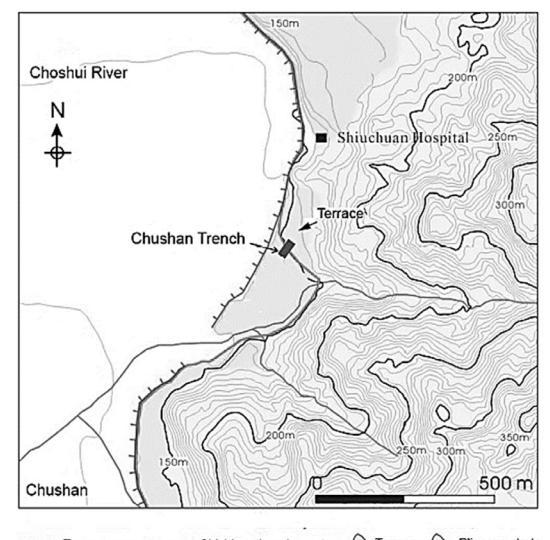
**Fig. 2.** Geological map of the CFPP and surroundings (modified from Chen et al. [8]).

The CFPP is located on an alluvial terrace near the southern boundary of the Zhuoshui River Valley. This park is situated on a mini alluvial fan formed from a gully to the southeast (**Fig. 2**). Geological studies have indicated that the shallow geology of the site consists of a series of unconsolidated strata of mud and fine sand. There is a thick gravel layer at a depth of 7.5 to 8.5 m to the west (footwall) of the fault zone. The gravel layer on the east side of the thrust fault was uplifted about 7 m, to about 2 to 3 m below the surface (**Fig. 3**). To the east of the CFPP is the Pleistocene Western Foothill Zone, which consists mainly of interlayers of sandstone and shale [8, 9].

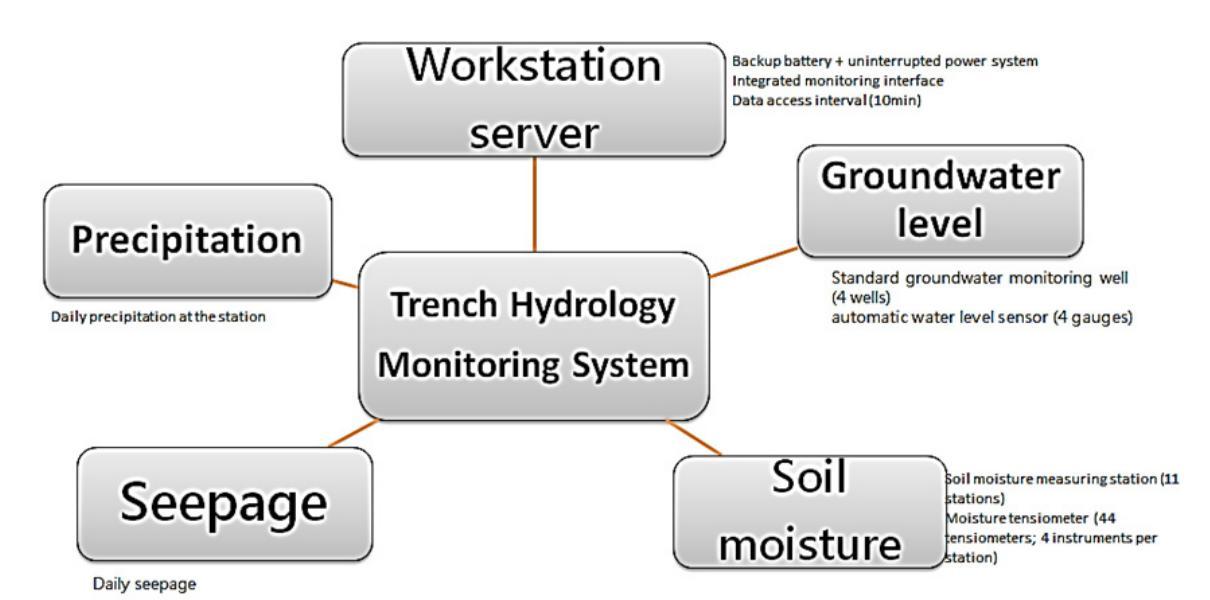
Fig. 9. Automatic monitoring system.

proper protection measures. The automatic monitoring system is an online, automated, and real-time information/data integration system. It collects hydrological data from instruments in the area around the trench, including groundwater level, soil moisture at different depths, amount of seepage, and precipitation (**Fig. 9**). The distribution of the monitoring devices is shown in **Fig. 10**.

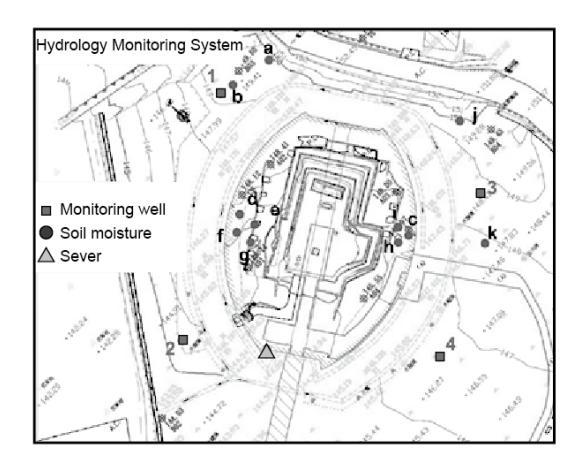
Fig. 10. Distribution map of hydrology monitoring instruments.

Four monitoring wells have been placed around the dome to monitor the groundwater table. There is also a precipitation recording station. Two seepage-volume recording stations monitor the amount of seepage from the north wall and the south wall of the trench, respectively. Eleven soil moisture monitoring stations have been installed inside and outside the dome. At each station, devices have been set up at four different depths: 0.5 m, 1 m,
